Northwest Highway and Oakton Street Westbound Approach

Automated Red-Light Camera Enforcement System Statistical Analysis and Evaluation

PARK RIDGE POLICE DEPARTMENT
200 VINE STREET
PARK RIDGE, IL 60068

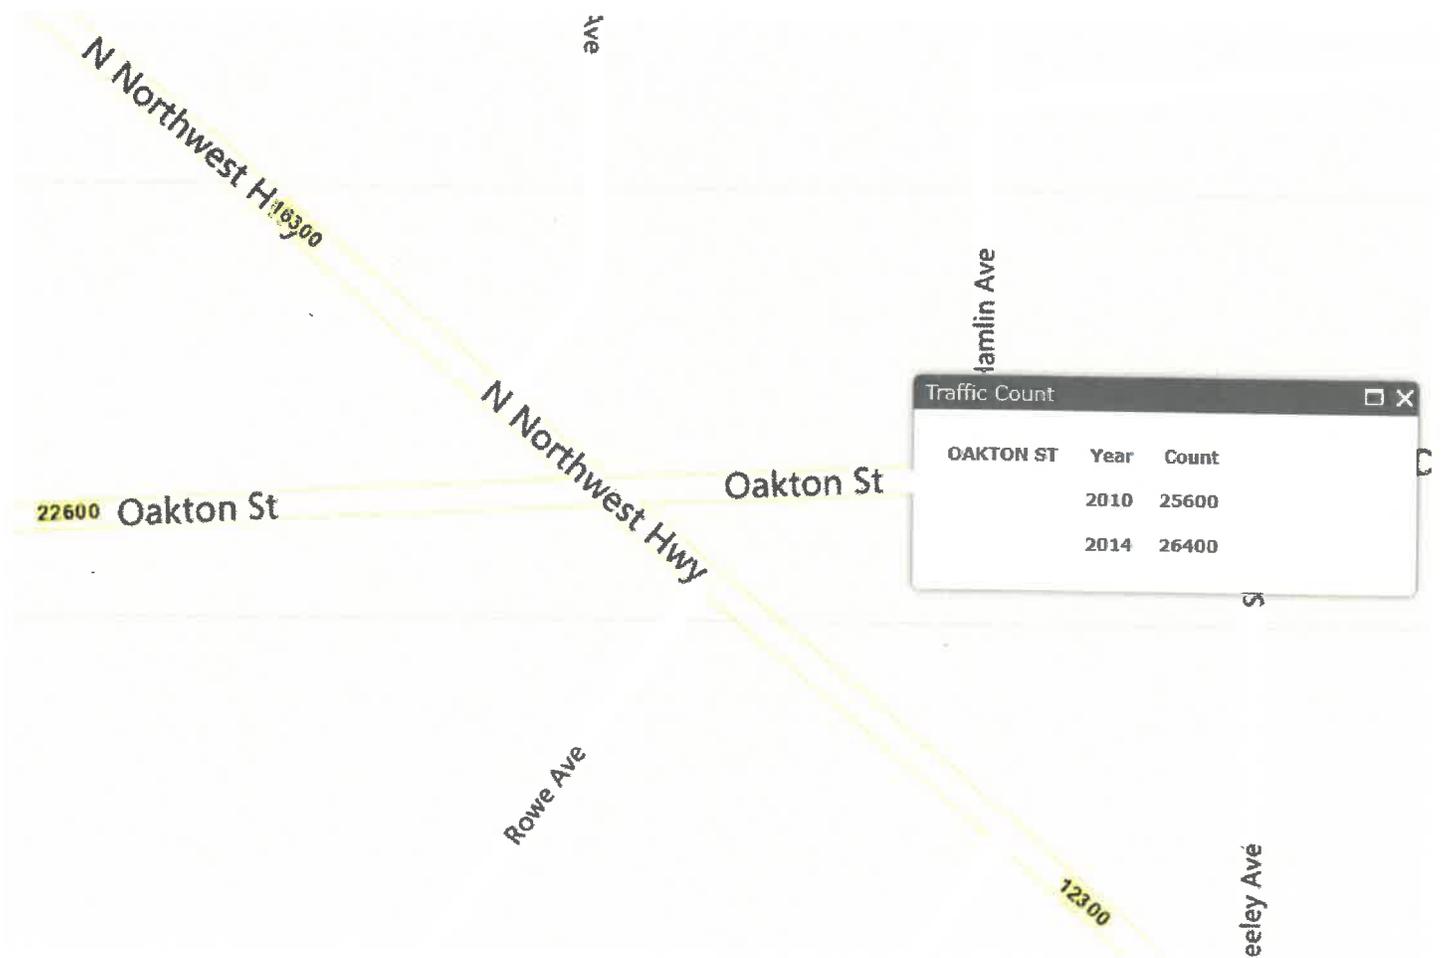
Northwest Highway & Oakton Street (Westbound)

- 25,600 (2010)
- 26,400 (2014)

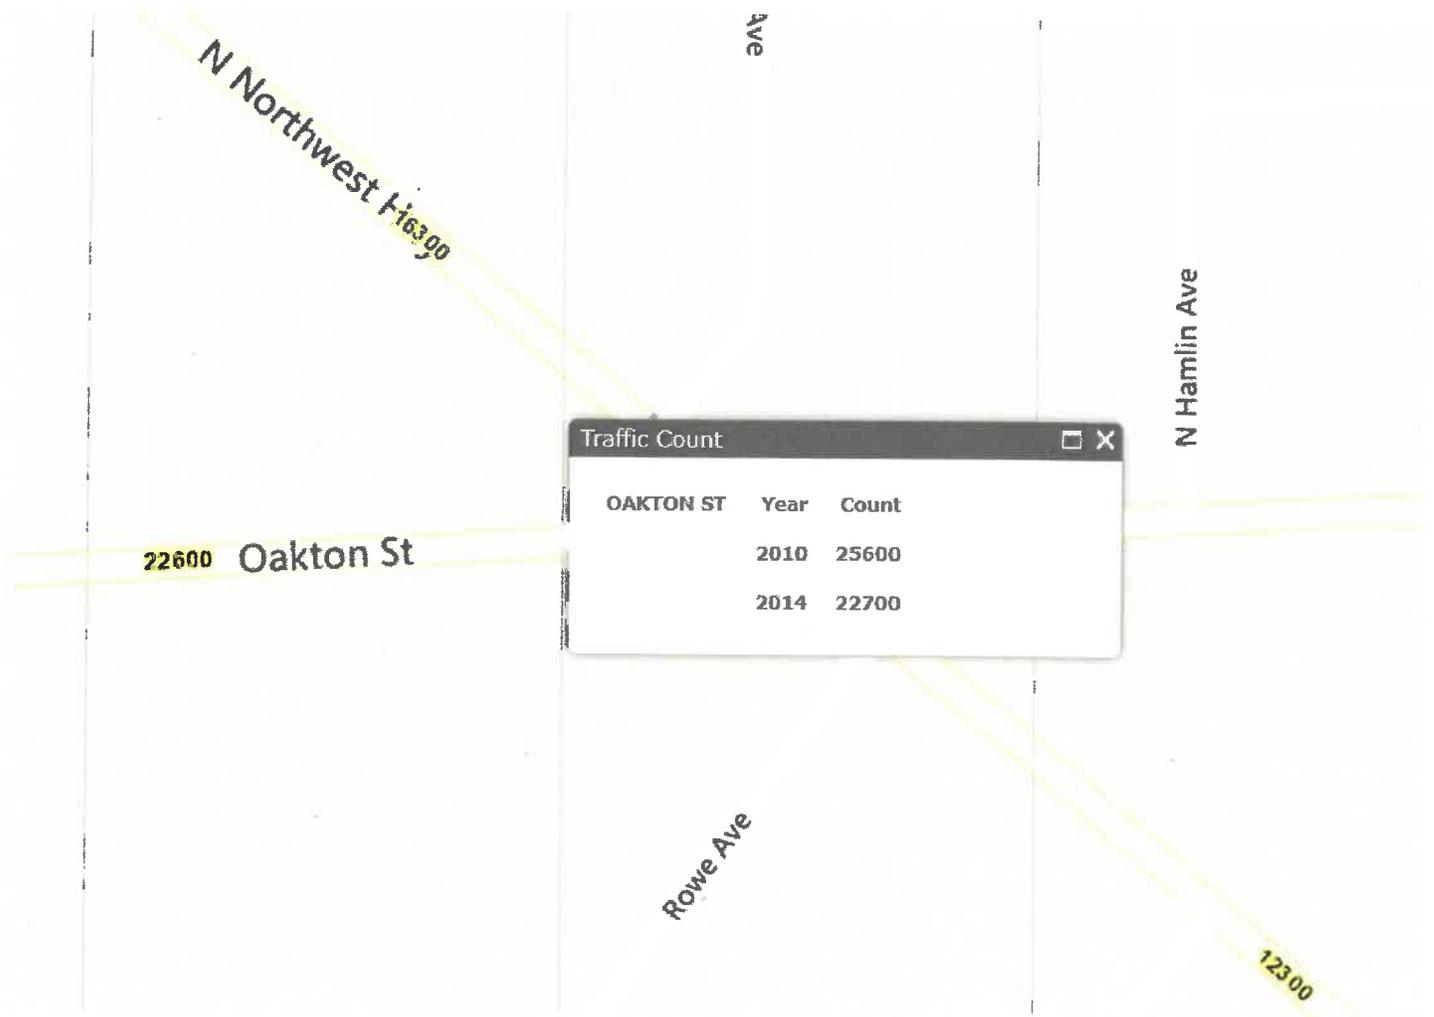
Northwest Highway & Oakton Street (Eastbound)

- 25,600 (2010)
- 22,700 (2014)

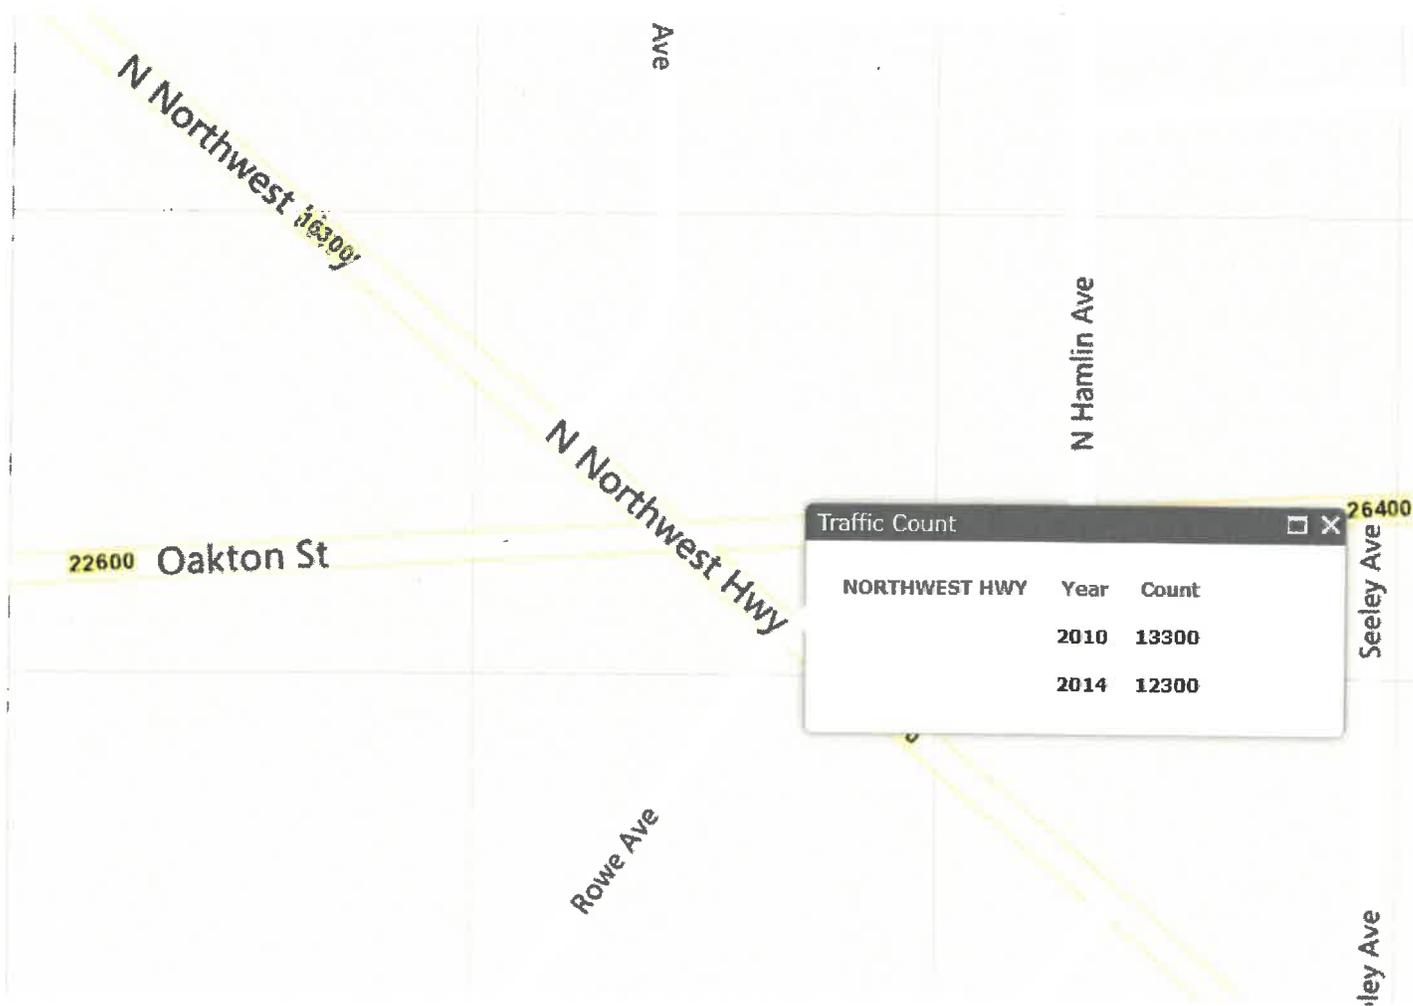
Northwest Highway & Oakton Street (Northwest-bound)

- 13,300 (2010)
- 12,300 (2014)

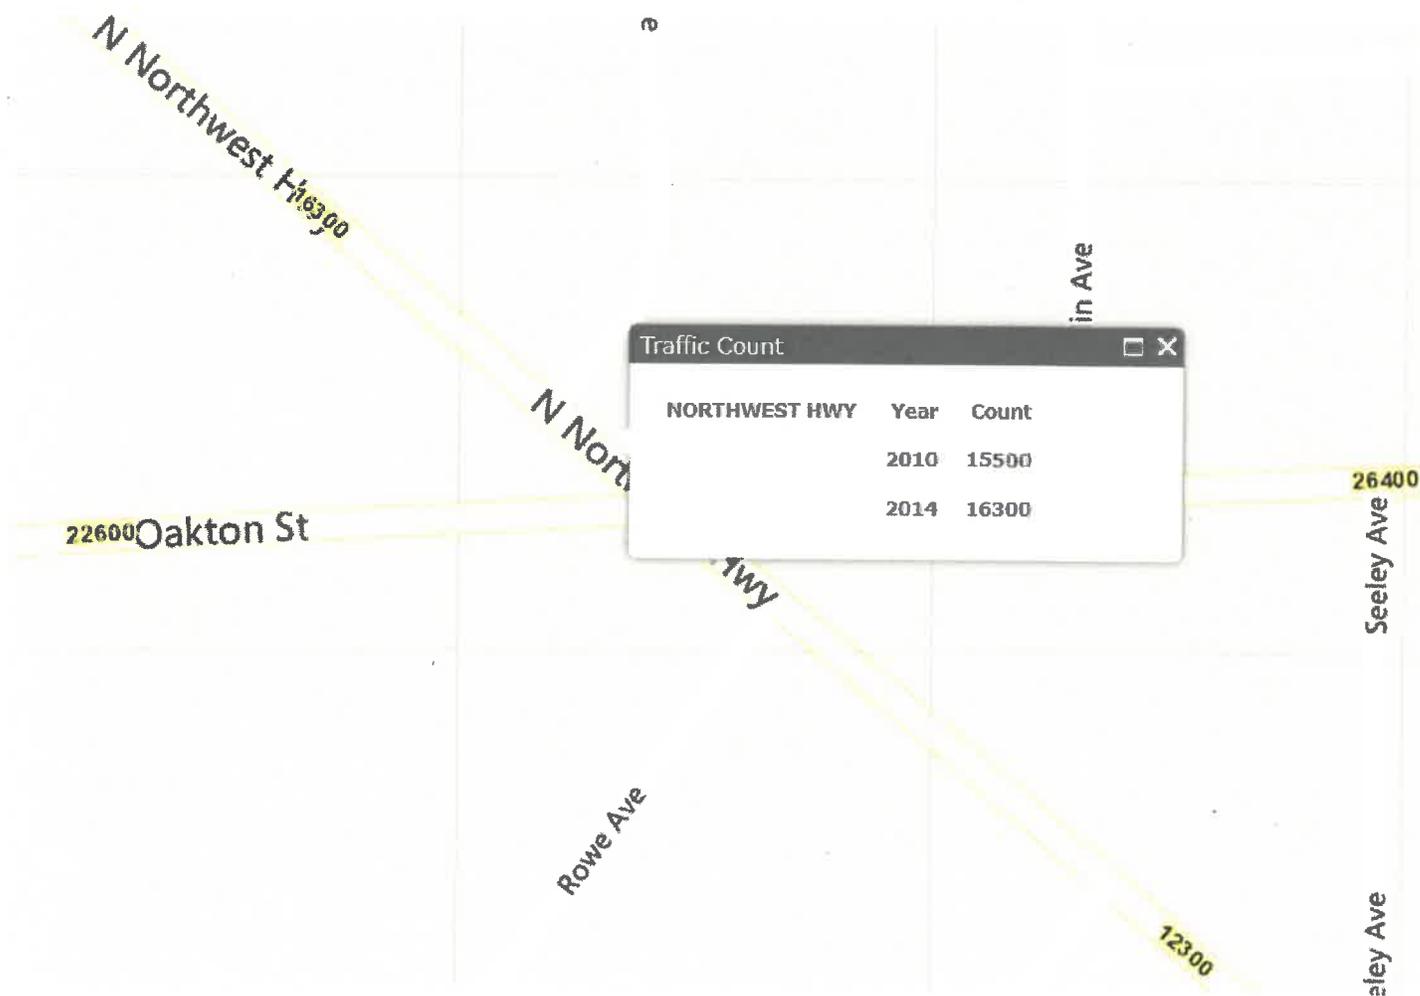
Northwest Highway & Oakton Street (Southeast-bound)

- 15,500 (2010)
- 16,300 (2014)
